Development Testing and Subsequent Failure Investigation of a Spring Strut Mechanism

Abstract

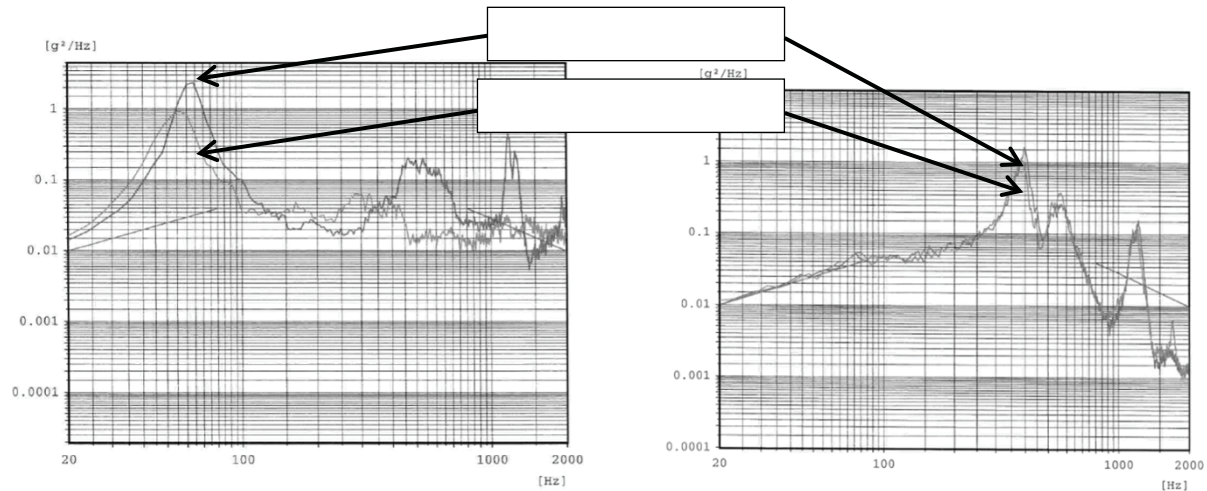
The test proceeded with the Z-axis first followed by the X-axis and finally the Y-axis. Each testing axis followed a similar pattern: minimum workmanship screening (MWS) and acceptance level loads were applied for 60 seconds, followed by the qualification levels for 3 minutes, and finally another MWS for comparison to the first MWS to assess changes in stiffness. Figure 5 illustrates discrepancies in responses that were seen upon comparison of the pre- and post-qualification level MWS runs in the Z-axis. The difference was found to be loosening of the aft cap during the qualification level testing. The aft cap was re-torqued and additional lockwire at a larger gauge was applied for follow-on testing. Figure 5 shows the minimal difference in the X-axis pre- and post-qualification level MWS runs. Additionally, the assessment team noted debris was observed exiting the spring strut when qualification levels were

applied in both Z- and X-axes. A borescope was used after testing in each axis to qualitatively assess the magnitude of internal wear and provide a comparison from axis to axis. For the Z- and X-axis testing, the hardware was exposed to the target levels with no significant (i.e., operation-inhibiting) damage observed and thus deemed successful.

Figure 5. Typical Pre- and Post-Qualification MWS Differences (Z-axis [left]; X-axis [right])

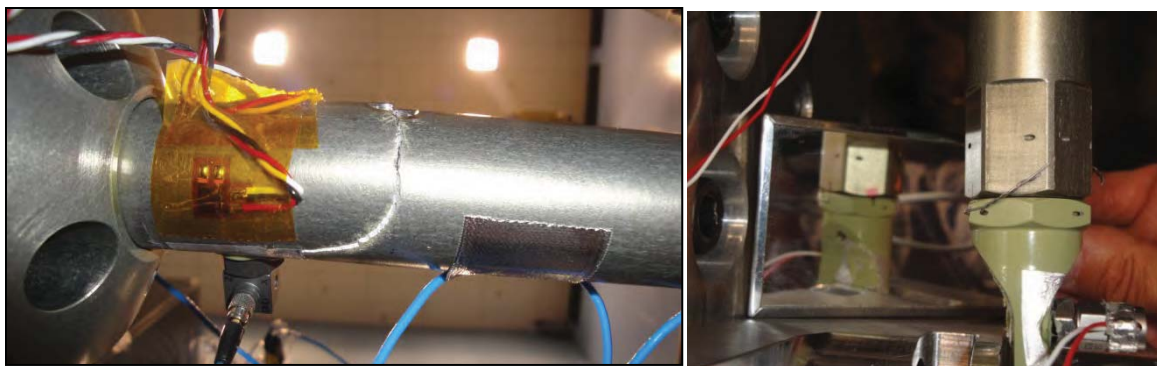
The Y-axis was anticipated to be the worst environment for the hardware. MWS and acceptance levels were completed in the Y-axis. However, during the qualification level test, a distinct change in the sound and response produced by the hardware was observed 27 seconds into the full level qualification run. A lack of clear visual failure indicators coupled with ill-defined criteria for test stoppage resulted in continuation of the testing to the full duration (3 minutes). Upon completion of the test, the NESC team found the secondary piston had failed at the aft tooling hole and the lockwire restraining the forward lug from rotating had failed (Figure 6). Due to the failure of the spring strut hardware, no further random vibration testing could be completed and the hardware was taken back for investigation and performance testing. Note that even though the test hardware incurred a failure, the testing was ultimately considered successful because it flagged design deficiencies before they were encountered late in the test and verification cycle.

Figure 6. Structural Failure of Secondary Piston at Aft Tooling Hole [left]; Lockwire Failure at Forward Lug [right]

Prior stress and fracture analyses did not include the tooling holes, and the secondary piston was not considered fracture critical. Large structural margins in this analysis deemed the secondary piston satisfied the definition of a 'low risk' component and were subsequently classified as non-fracture critical. These prior analyses were based on flight load factors found to be inadequate and inconsistent with the EFT-1 flight configuration. After the secondary piston failure, an updated fatigue analysis was performed accounting for the off-nominal secondary piston rotation to quantify the Cumulative Damage Index (CDI) using Rayleigh's distribution and Miner's Rule for response to the base input Power Spectral Density (PSD). In summary, the analysis results showed exceedance of the secondary piston fatigue life capability at the tooling hole ($CDI = 1.519 > 1.0$) when subjected to Y-axis qualification levels in a maximum bending condition. After the failure, the spring strut was evaluated by LM and Marshall Space Flight Center (MSFC) failure analysis groups with both groups concluding the structural failure occurred at the aft-most secondary piston tooling hole initiated in fatigue followed by ductile overload. The opposite side of the failed tooling hole also showed the beginnings of fatigue cracking.

Due to the rotation, strut tooling holes, nominally in the neutral bending axis during the Y-axis vibration test, were placed in maximum bending. Once the fatigue life capability at the tooling hole was exceeded, the secondary piston failed by crack growth and overload.

The NESC team was kept apprised of the redesign activities by the MPCV CM subsystem management team. LM made design changes intended to prevent loosening of the threaded parts and eliminate fatigue initiation sites, then retested the strut. These changes included an increase in the size of the secondary locking patches, quantity and diameter of lockwire, and preload at the end fitting joints (50 percent of F_{ty}). Additionally, the tooling holes were removed and a new retention tool design was devised. Once the initial redesign effort was complete, LM began with the Y-axis test, which was the worst case and the axis in which the secondary piston failed. Shortly after reaching qualification levels, the strut suffered another failure. This time, the forward lug fractured at the secondary piston interface. A subsequent investigation by LM determined fatigue failure was the cause and that the corrections made appeared to be working up to the point at which the testing was stopped. The LM retest had reused a majority of the hardware from the original test unit (including the forward lug) without a residual life assessment. Analysis revealed the fractured rod end had exceeded its fatigue life capability. Gapping in the joint between the rod end and the secondary piston exacerbated the problem.

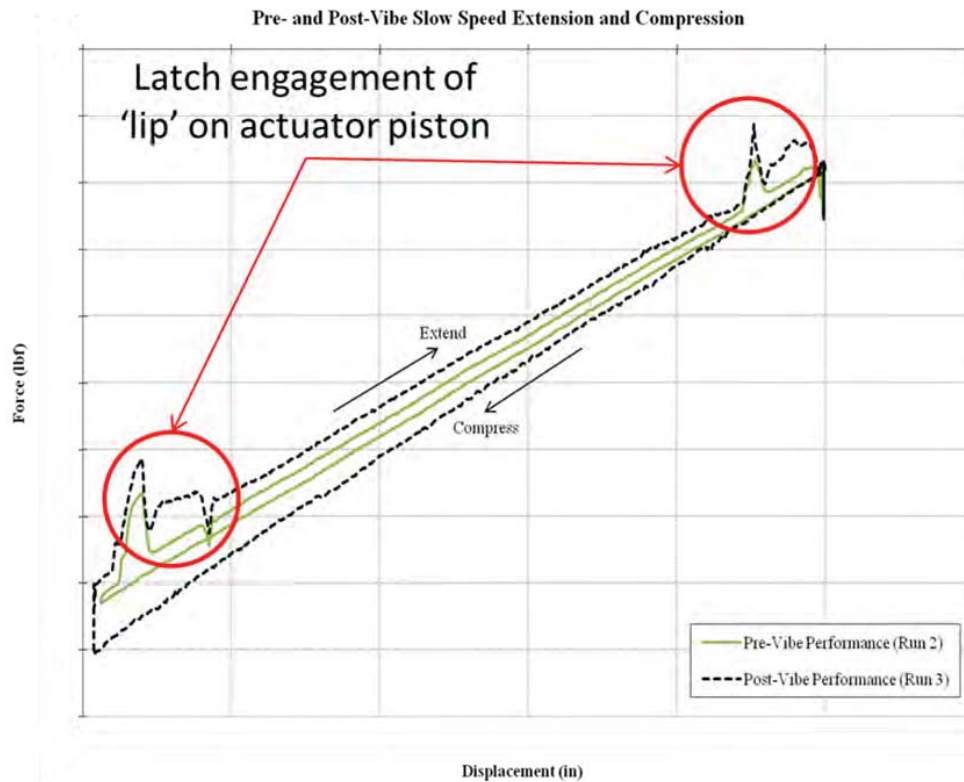
After failure during the random vibration testing, the strut was returned to the performance testing facility with a truncated secondary piston to remove the failed portion of the strut. Using a cupping interface, post-vibe performance deployment tests were performed with the strut assembled in the load frame. The post-vibration performance test served primarily to assess whether there were any large excursions from the nominal force-deflection curve. These excursions could be indicative of significant damage to the spring strut sliding surface. The post-vibration performance test satisfied the nominal expected end of travel force of $165 \text{ N} \pm 27 \text{ N}$ ($37 \pm 6 \text{ lbf}$) and resulted in nominal engagement of the anti-back travel latches. Force versus displacement within the expected tolerance yielded acceptable force margin based on the next high assembly assumptions and calculations. A comparison of the pre- and post-random vibration performance test is shown in Figures 8.

Figure 8. Force versus Displacement Plot for Slow Speed Extension

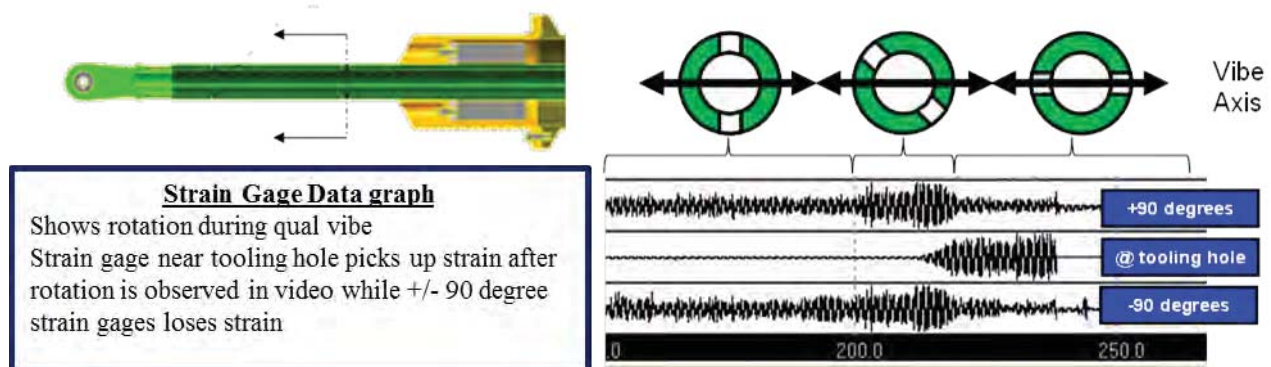
1. **Test Video and Strain Gauge Data:** Immediately after application of the qualification levels, the SM side assembly (aft cap, actuator housing, and forward cap) rotated clockwise (looking SM to umbilical side). Lagging this rotation, the secondary piston was observed to rotate counterclockwise. Inspection of data from strain gauges mounted on the secondary piston and visual indicators of mounted accelerometers indicated a rotation of approximately 90 degrees. Strain gauge data with indicators of tooling hole orientation relative to the Y-axis applied load can be found in Figure 10. Approximately 27 seconds after application of qualification levels (242 seconds) there was a noticeable decrease in noise and strut dynamic response. No noticeable damage was observed, so the test was continued to the full duration at 395 seconds.

Figure 10. Strain Gauge Data and Strut Rotation

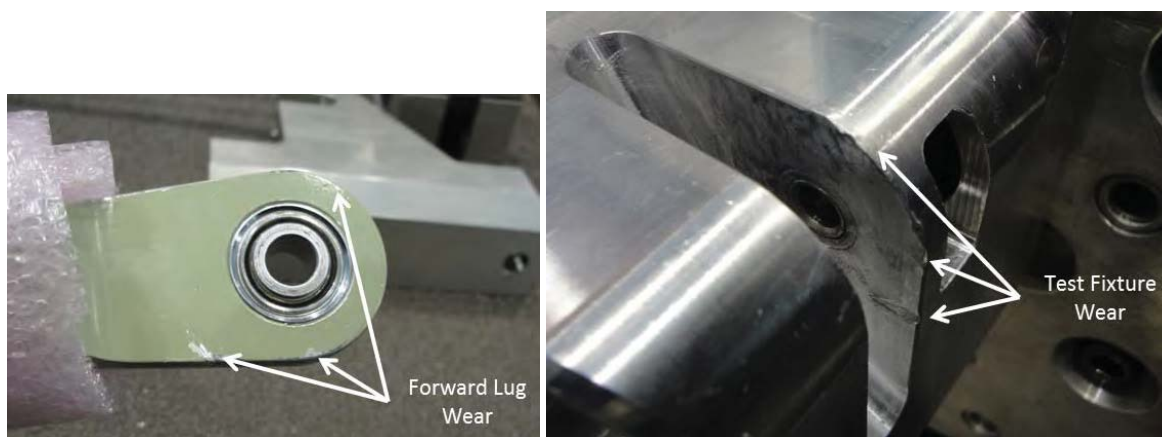
7. **End Fitting Rotational Offset:** Indications of wear are evident on the end fittings and adjoining clevises (Figure 11). Contact due to misalignment/rotational offset would have imparted a force off-axis from the strut and induced a torque applied to the end fittings. If the force was sufficient to overcome resistive elements of the joint, then the end fittings could have tightened or loosened. Loosening at the forward strut interface would have permitted an applied torque to more easily rotate the secondary piston relative to the forward lug.

Figure 11. Wear Post-Vibration Testing (Forward Lug [left]; Test Fixture [right])

During vibration testing there was contact between the aft cap and SM side actuator bracket and the forward lug and test fixture, with significant wear observed during post-test inspection. This produced a constraint and source of induced reaction force off-axis from the strut. The strut design also permitted a CG offset due to a combination of sliding contact interfaces, machining tolerances, non-axisymmetric nature of select piece parts, elastically buckled spring, and gravity loads as installed in the random vibration test fixture. The design also did not include an alignment feature integral to the strut, therefore forward lug and aft cap strut end fitting alignment was not guaranteed and permitted rotational misalignment between the two rod ends.

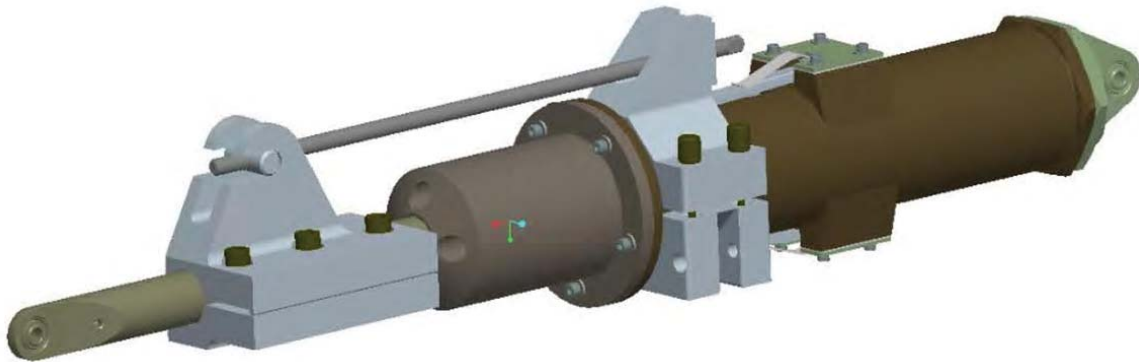
Figure 12. Updated Spring Strut Design

LM performed a residual life assessment on all parts to identify any other components at risk. Those items with insufficient life were replaced. Numerous design changes as shown in Figure 12 were also incorporated: the secondary piston was redesigned to eliminate the joint between the rod end and the secondary piston by replacing the assembly with a rod end integral to the secondary piston, the tooling hole interface to the retention tool was replaced with a clamp-style tool, and the aft cap-to-actuator housing interface was adhesively bonded after application of the required preload. The new design was placed through a new random vibration test, this time using an approach that included qualification for AVT per reference 5, and the unit passed the vibration test and post-vibration performance testing.
